# Comparison of Two Types Implant Supported Crowns in Anterior Section

Eva Haskova, Lenka Vavrickova

Department of Dentistry, Faculty of Medicine in Hradec Kralove, Charles University in Prague, Czech Republic

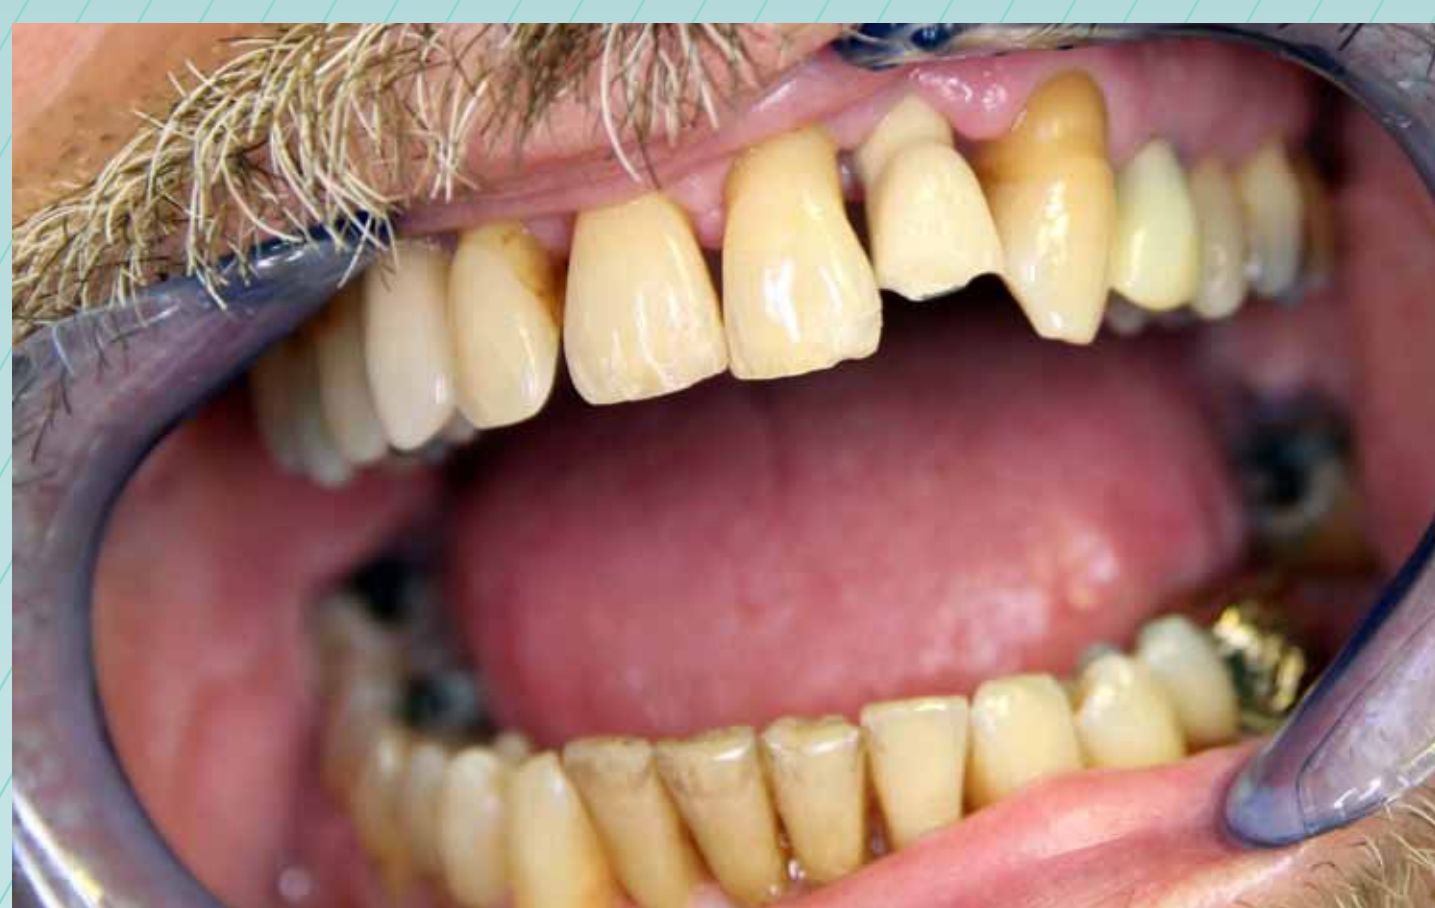
Figure 1A: Chipping off the ceramic layer to the metal coping in loco 012 buccal view.

Chipping and chipping off the ceramic layer to the metal coping (Fig. 1A, 1B) were considered as a complication for PFM crowns. Chipping, all-ceramic crown fracture, all-ceramic crown and also abutment fracture, bond failure between zirconiumoxide and titanium part of the abutment were evaluated for all-ceramic crowns. In a sample of 705 patients with 246 all-ceramic crowns and 614 with PFM, seven all-ceramic and 91 PFM crowns were not evaluated for non-cooperation of the patients. That's why the retrospective study included 681 patients with 239 all-ceramic crowns and 523 PFM crowns (Graph 1).

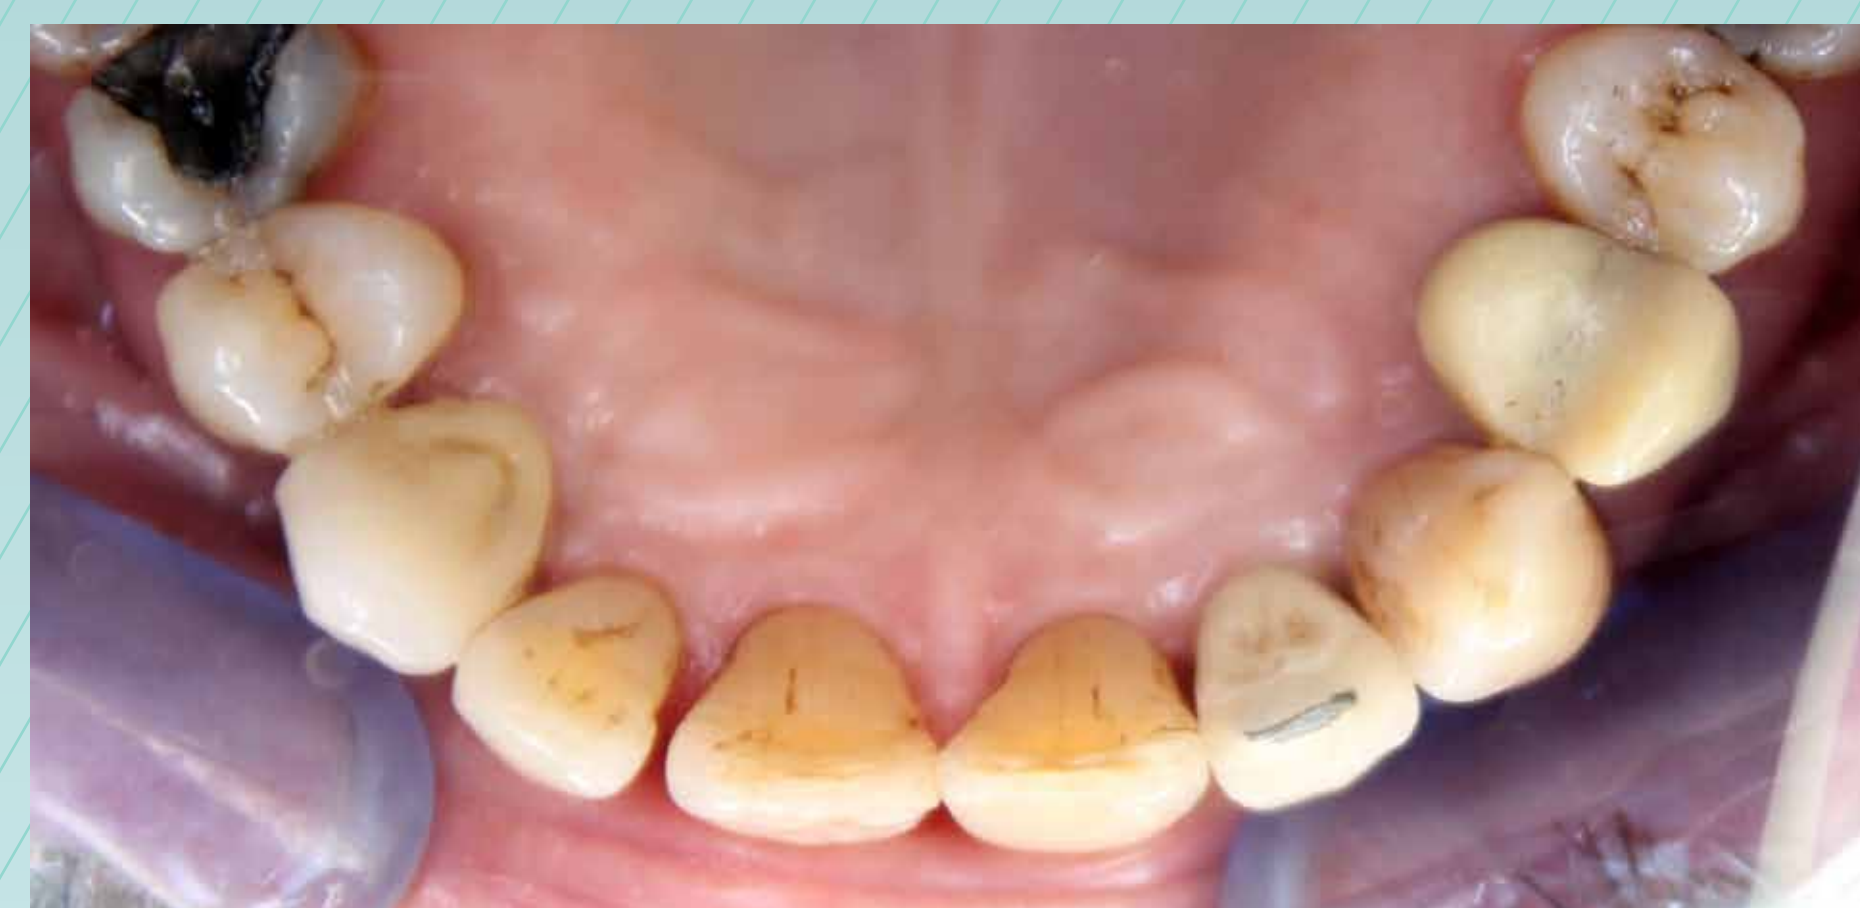
Figure 1B: Chipping off the ceramic layer to the metal coping in loco 012 oral view.

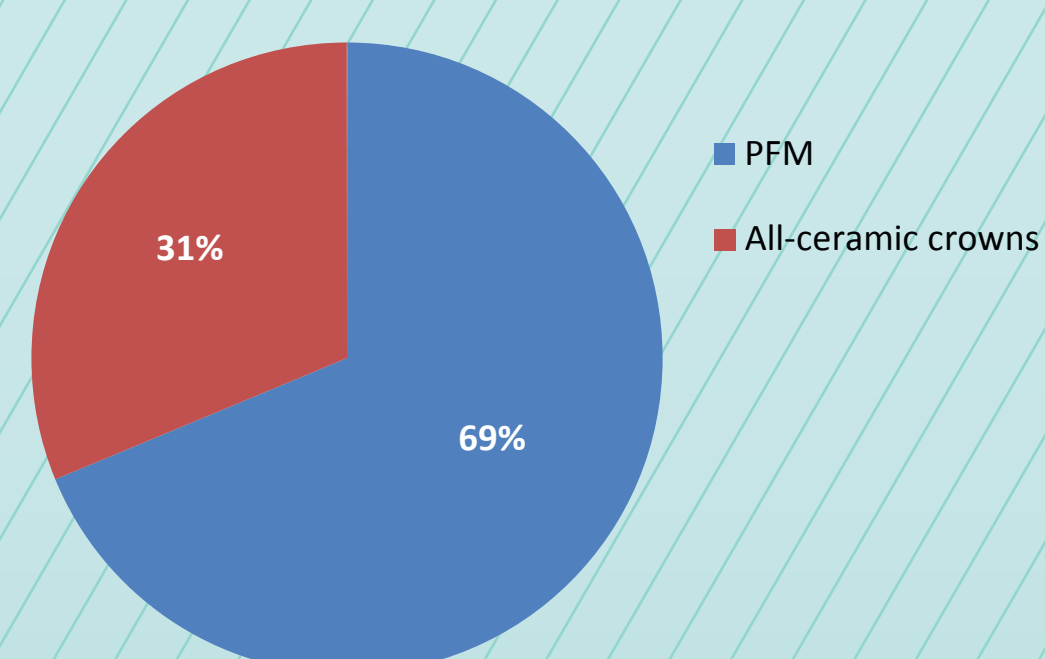
Graph 1: PFM and all-ceramic crowns fabricated in 2010-2014.

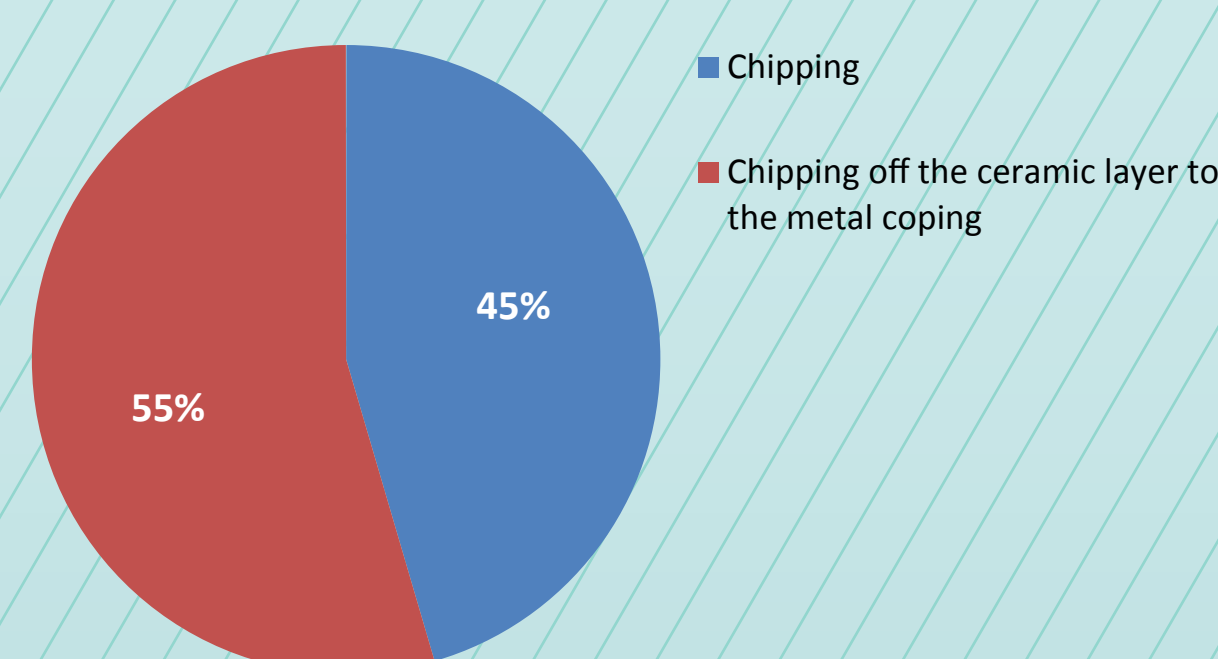
Graph 2A: Type of PFM complication.

There were found complications as chipping as well as chipping off the ceramic layer to the metal coping for PFM in 2.1 % (11 in total). Graphs 2A and 2B show type of complication and its localisation for PFM crowns. Chipping, all-ceramic crown and abutment fracture as well as bond failure between zirconoxide and titanium part of the abutment were found in 2.0 % for all-ceramic crowns (5 in total). Graphs 3A and 3B show type of complication and its localisation for all-ceramic crowns. No single all-ceramic crown fracture was observed. Graph 4 shows the highest number of complications for PFM crowns within 4 years of the use. For all-ceramic crowns we noticed highest number of complications after 3 and 1 years (Graph 5). Graphs 6 and 7 show types of complication dependant on use time.

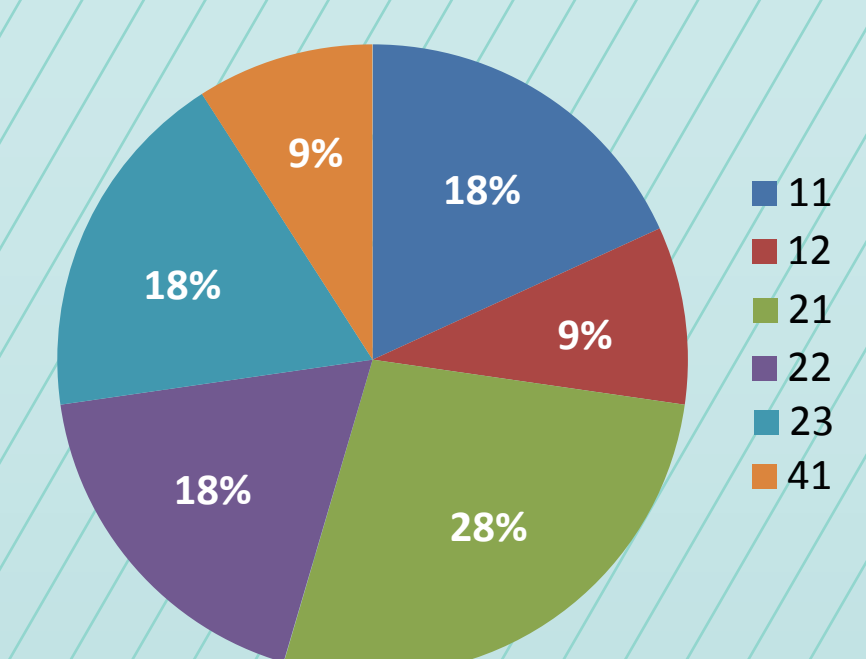
Graph 2B: Localisation of PFM complication.

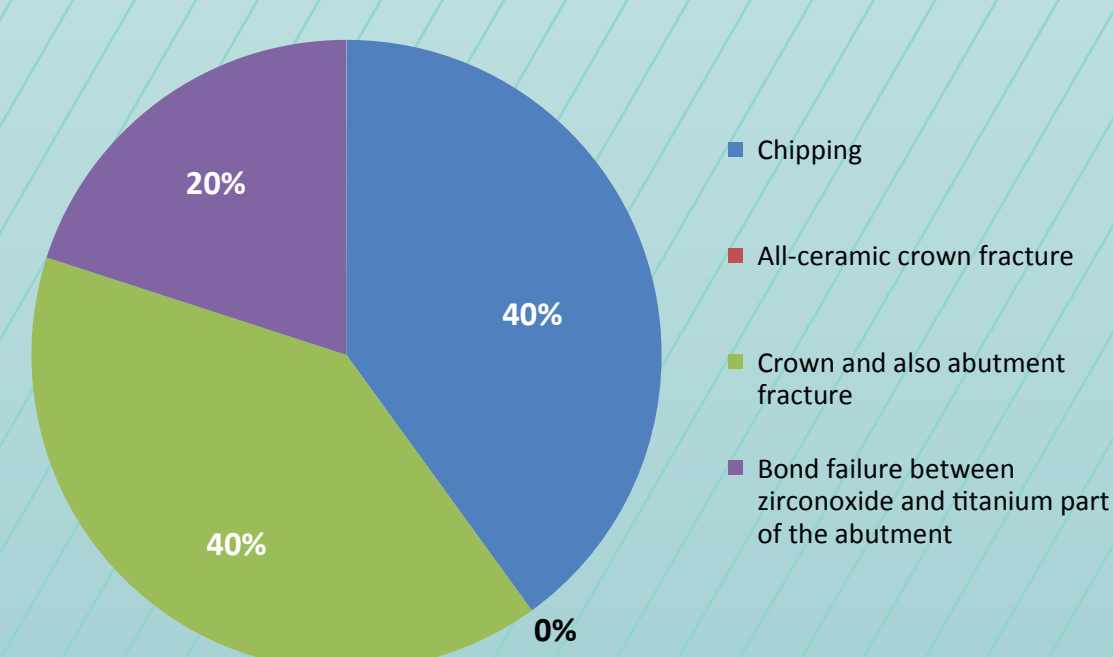
Graph 3A: Type of all-ceramic complication.

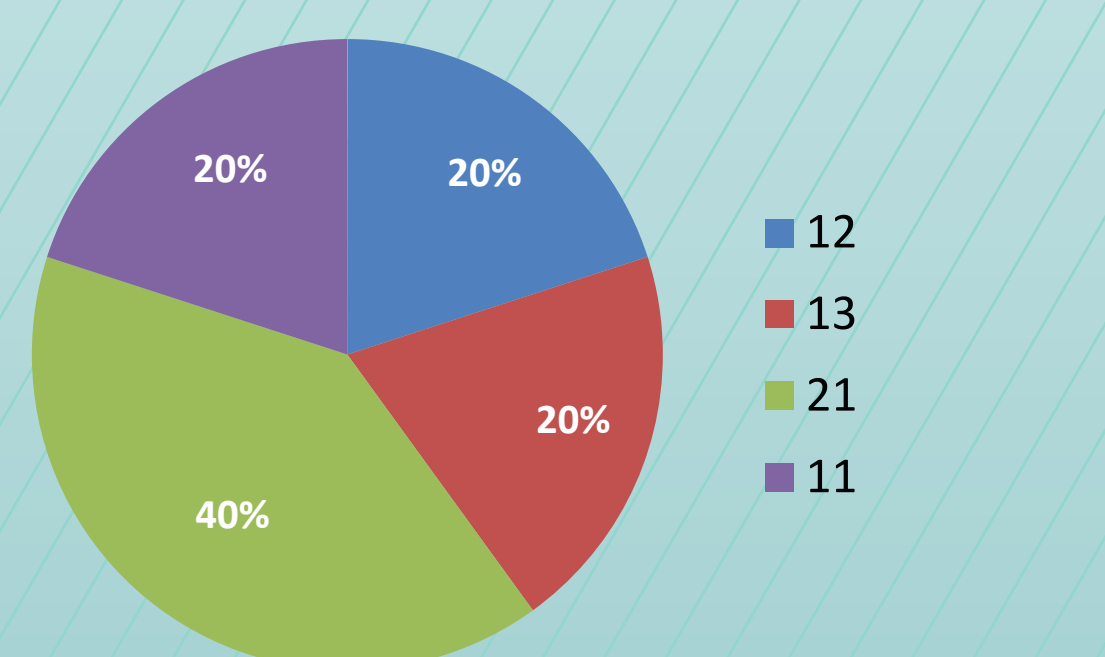
Graph 3B: Localisation of all-ceramic complication.

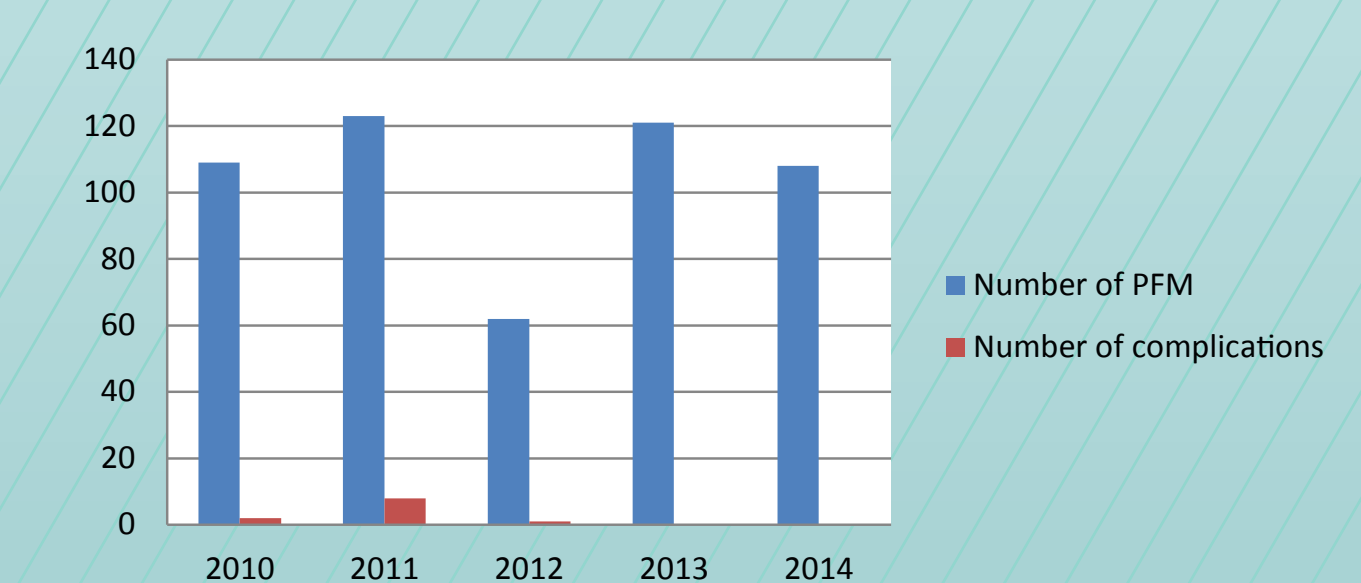
Graph 4: Number of PFM complications dependent on use time.

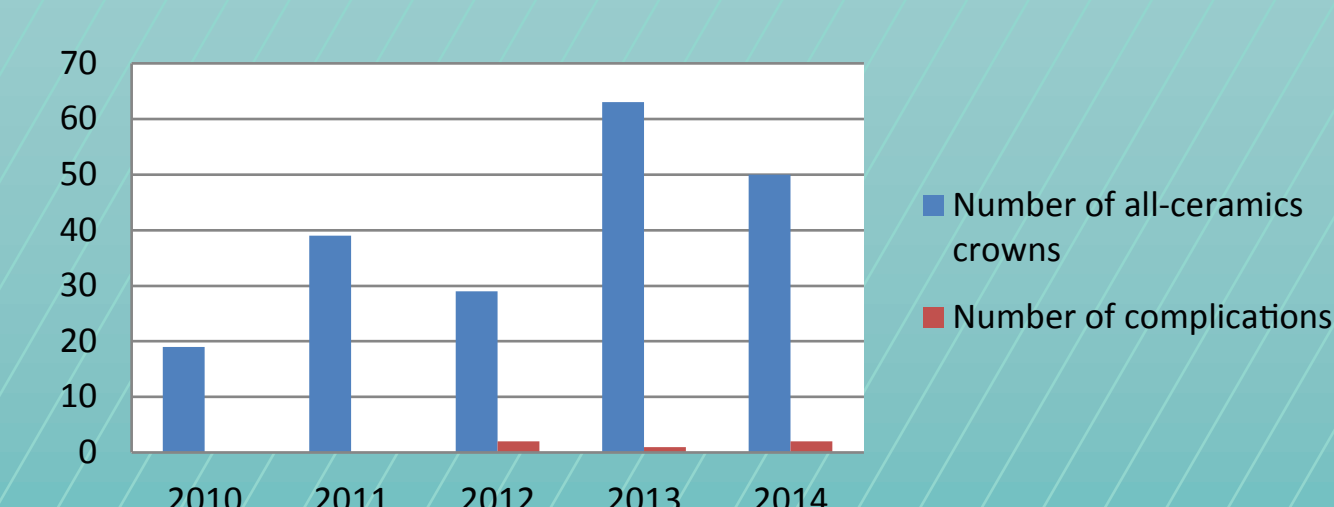
Graph 5: Number of all-ceramic crowns complications dependent on use time.

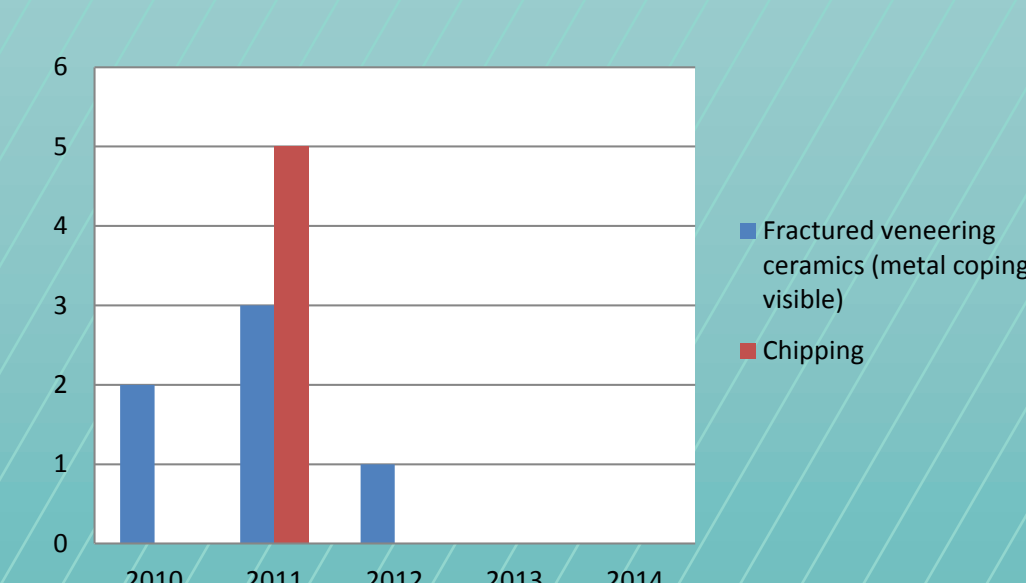
Graph 6: Type of PFM complications dependent on use time.

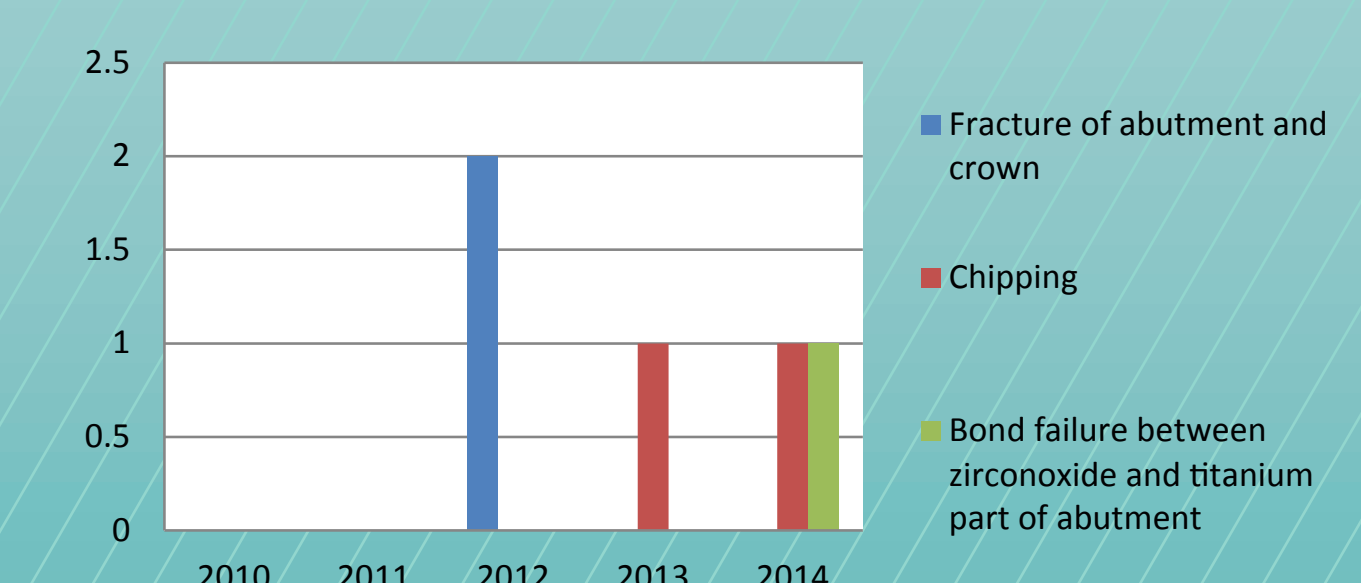
Graph 7: Type of all-ceramic crowns complications dependent on use time.
